CHARACTERIZATION OF METALS MELTING DISCS
SKYLAB EXPERIMENT M551

Robert E. Monroe

BATTELLE COLUMBUS LABORATORIES
Columbus, Ohio 43201

December 4, 1973

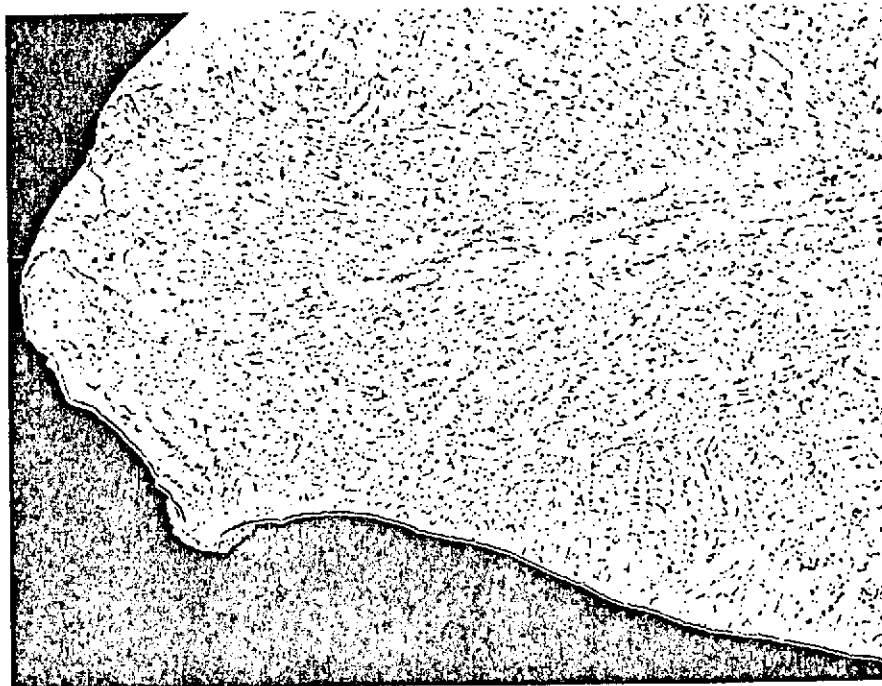
FIGURE A-6. SURFACE OF CUT ON INSIDE -H-1

Figures A-5 through A-10 show the appearance and microstructural details in the cut region. Several areas on the cut surfaces indicate the presence of a contaminant or reaction zone. This has probably come from material vaporized from the surface under the weld disc. The very wide cut that resulted in this disc is

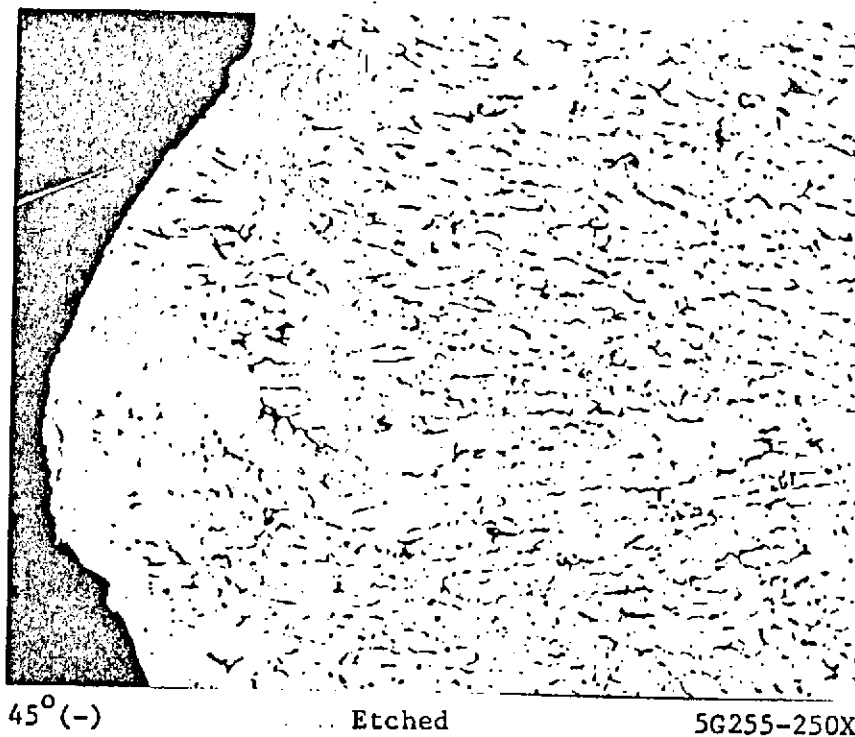
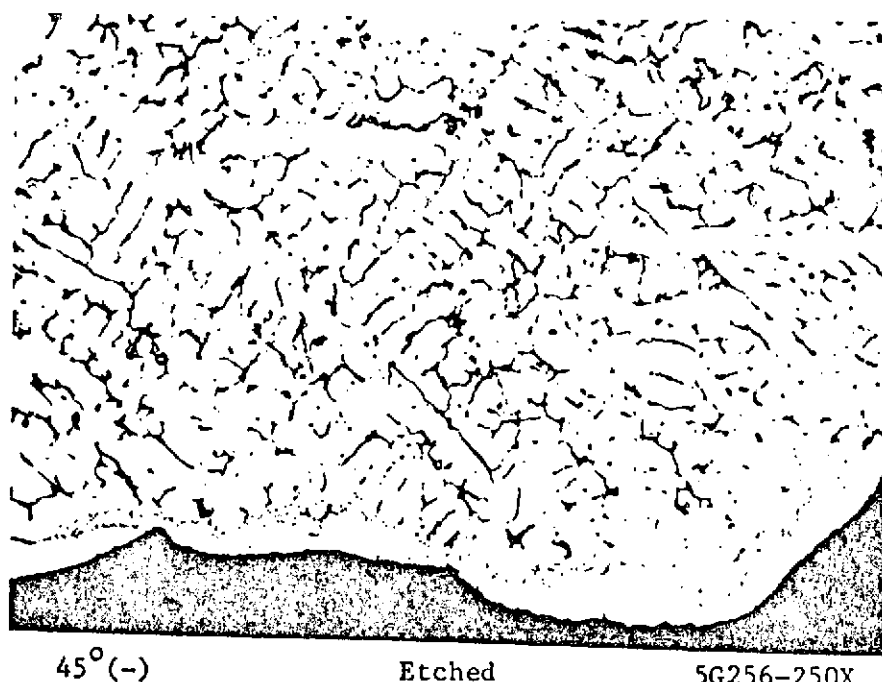
FIGURE A-7. SURFACE OF CUT -H-1

a. Enlarged area of Figure A-6

b. Bottom surface of cut on outside

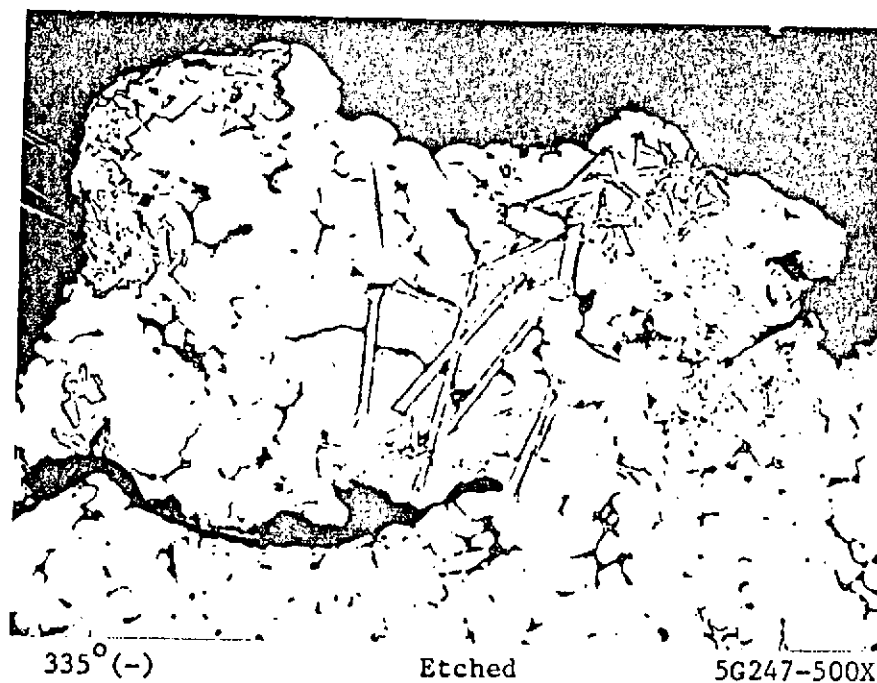
FIGURE A-21. MOLYBDENUM TRACES ON SURFACES OF
DWELL REGION- H-1

b. Near right center in Figure A-19

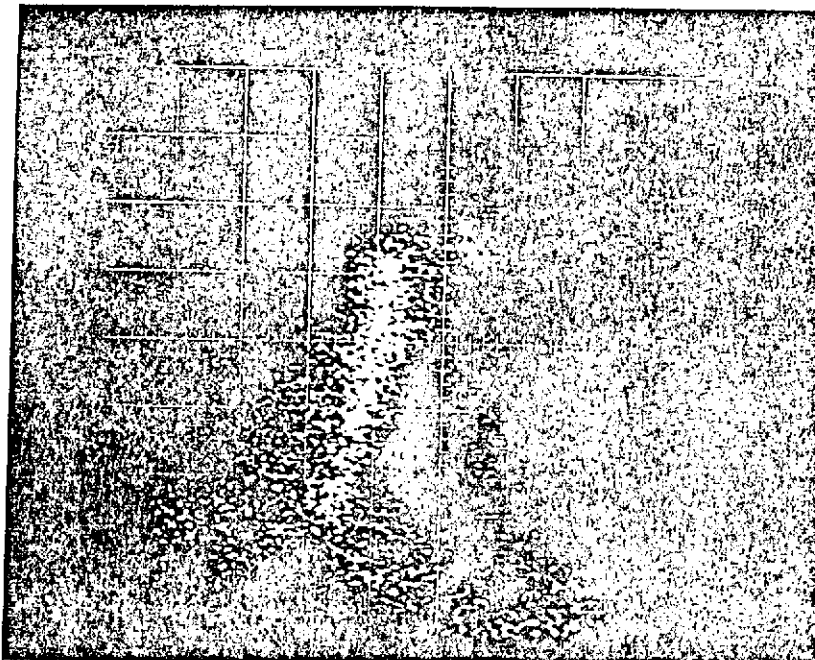
FIGURE A-24. ELECTRON PROBE SCANS OF REGION SHOWN IN FIGURE A-21 - LARGE PARTICLE AT LEFT CENTER ADJACENT TO END OF CREVICE - H-1

The details shown in Figures A-11 through A-23 are provided for future comparisons of structures and defects. Figures A-24 and A-25 illustrate the technique available to identify phases present in the regions containing the molybdenum tracer.

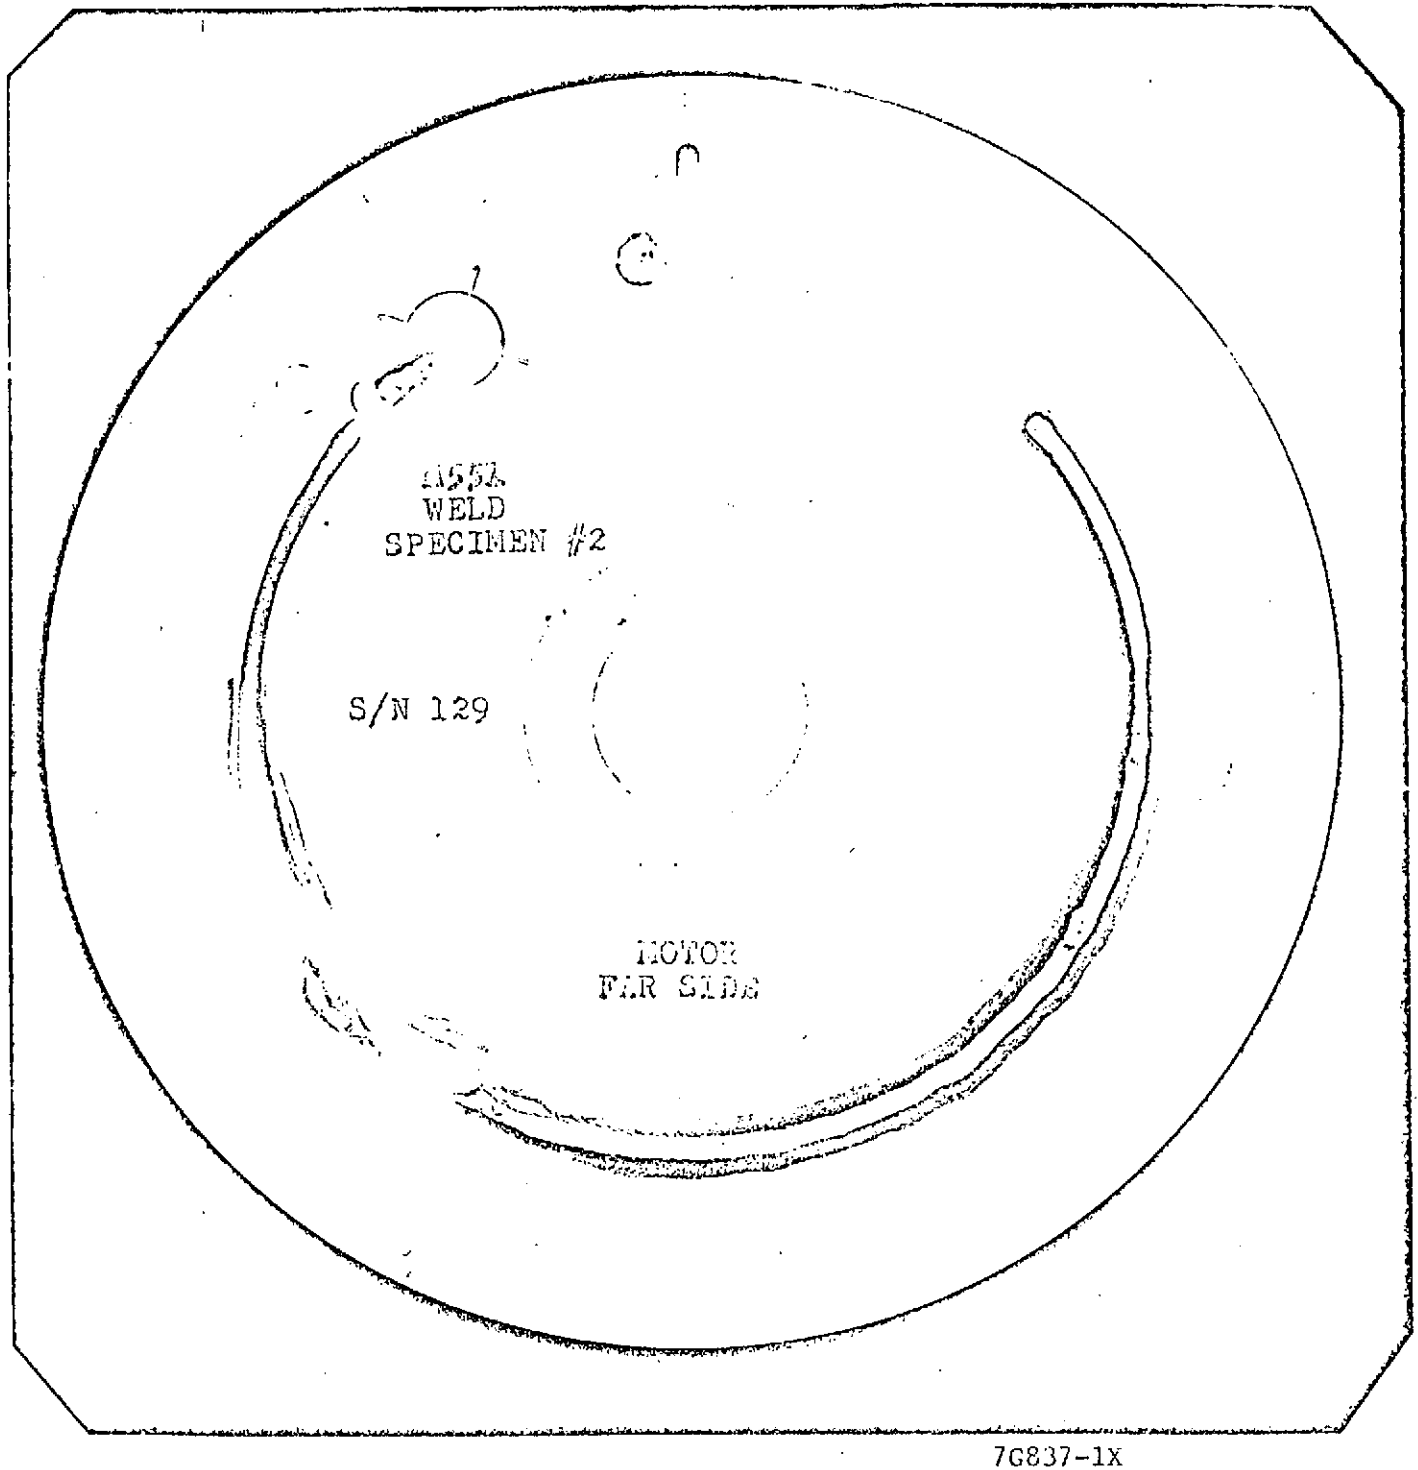
FIGURE B -3. FRONT SURFACE S/N 129

At 0 degrees, the target shows good positioning of the electron-beam; almost exactly dead center. There is a short weld region on the tungsten which is not contaminated by aluminum which did flow back onto the outer edge of the target for a short distance. A short length of weld then exists up to the point where cutting starts. There is a shrinkage crack in the termination of this short length of weld. The initial width of the cut region is 6 millimeters. For most of the rest of the cut, the cut narrows to approximately 2 millimeters in width. Material from the cut region formed a bead on either side of the cut. This bead is much heavier on the inside edge of the cut. Several more massive accumulations of molten metal exist along the cut region. One at about 20 degrees, one at about 70 degrees, and one at 95 degrees. The region between about 80 and 100 degrees is very erratic in appearance with the cut width varying considerable and a very massive ball of molten material on the inside edge, as mentioned previously at 95 degrees. Welding starts at about 100 degrees with only a very slight indication of a starting crack. Weld ripples are fairly pronounced although the surface is quite molted with a brownish spot-type deposit in the center region with a dark appearance on the outer region of the weld. The weld continues fairly uniform in appearance until the molybdenum tracer region is reached. Initially, at that point, there is a depression in the weld surface and numerous small hairline cracks are apparent in this area. Once the weld passes by the tracer region, it again assumes a uniform appearance with clear surface ripples and very little evidence of the brown spotty material in the center. The center region for the remainder of the weld is basically bright and clean; the brown material appears to have remained along the edges of the weld. The weld terminates in the finish hole with some slight cracking in the weld center. The initial weld width is 8mm; it then narrows to 6mm (full penetration) then to 4mm (partial penetration).

The dwell region was focused slightly to the inside and beyond the intended 330 degrees. The bulk of the dwell which is basically circular in appearance, is completely outside of the two legs of the molybdenum target. The dwell extends under these two legs but does not appear to have reacted with either leg very much. There are a number of shrinkage cracks in the center of the dwell region which is depressed. In general, the dwell periphery is raised above the surface of the plate being approximately even with the surface at the top. The center of the dwell is quite bright with the outer fringes of the molten zone appearing with a light brownish surface coloring. The dwell measures 15 X 12mm.

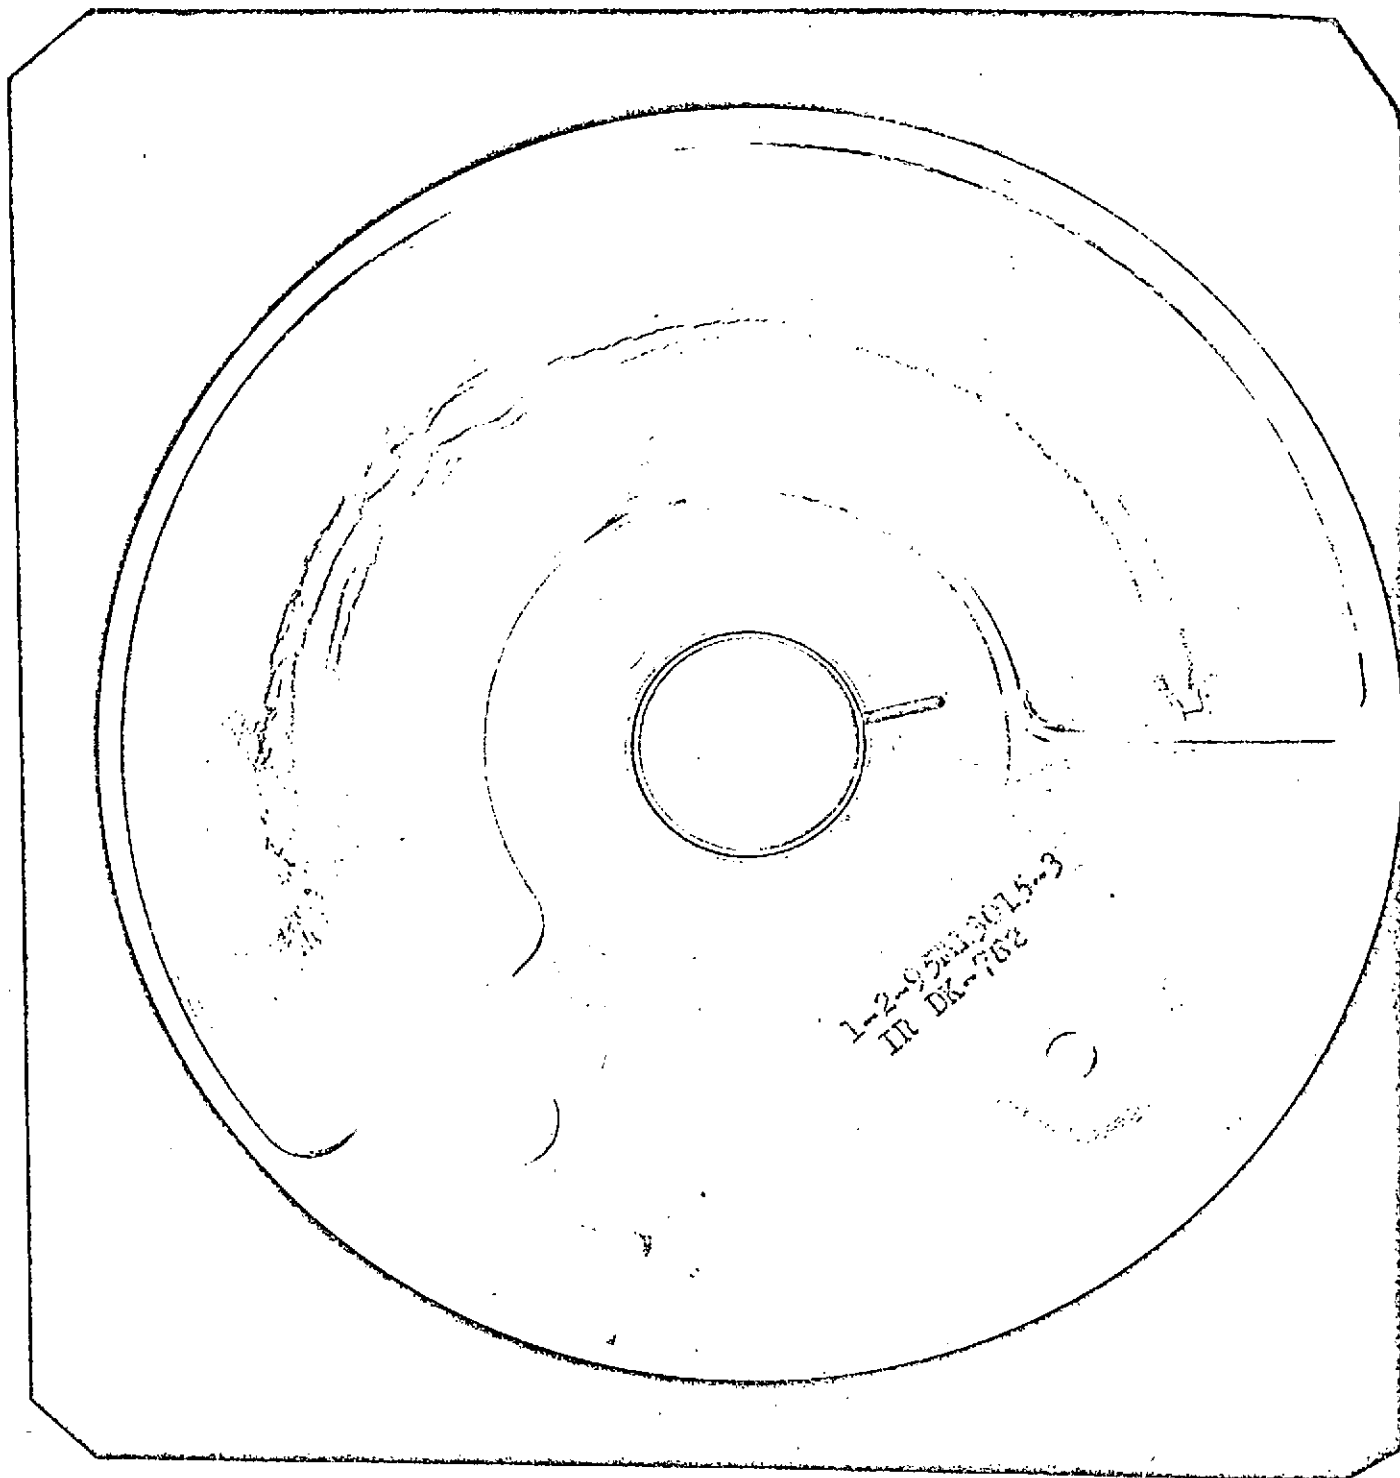
FIGURE B -4. BACK SURFACE S/N 129

At the target, there is nothing of significance. The cut area looks very much like the top surface but is not as smooth and to some degree, looks a little dirtier. Where welding starts, the hot crack is apparent on the undersurface extending from the start of the weld until approximately 150 degrees. Ripples appear to be evident on the under weld surface starting at approximately 180 degrees. These ripples are quite elongated. Small check like indications in the heat affected zone are evident between 210 degrees and about 225 degrees. These are possible heat-affected zone cracks, but this cannot be confirmed visually. The cracks evident on the top surface at about 240 degrees are also evident on the lower surface. From 240 degrees to the weld termination hole, there is no evidence of welding; however, the area around the hole itself is slightly discolored.
